RAPID SITUATION ANALYSIS REPORT

# BHOTEKOSHI-TRISHULI CATASTROPHIC FLOOD

*Jointly Prepared by: Youth Alliance for Environment (YAE); Himalayan Cryosphere, Climate and Disaster Research Center (HiCCDRC); Kathmandu University (KU); Society for Conservation Biology Nepal*

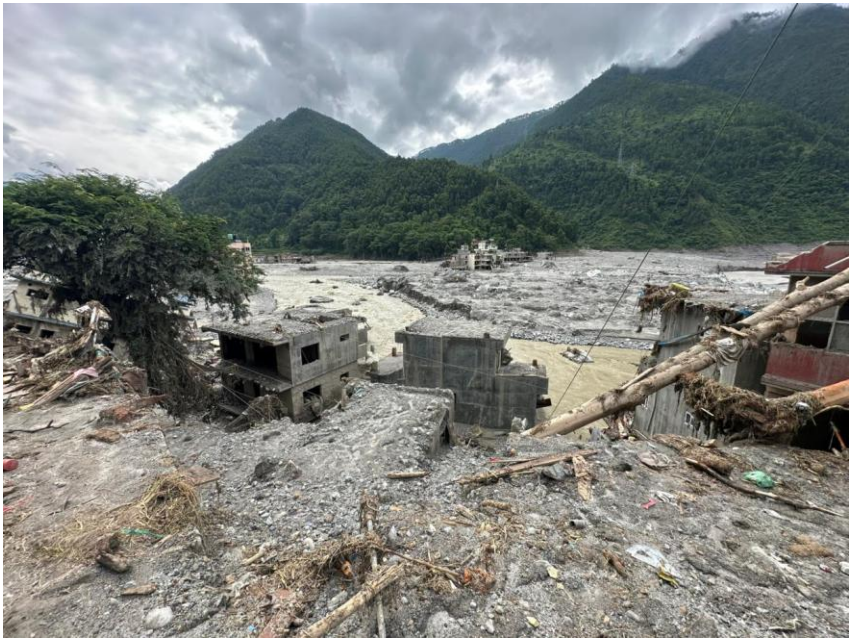
*A view at flood-impacted area of the Betrawati Bazzar (Photo Credit: Saroj Adhikari)*

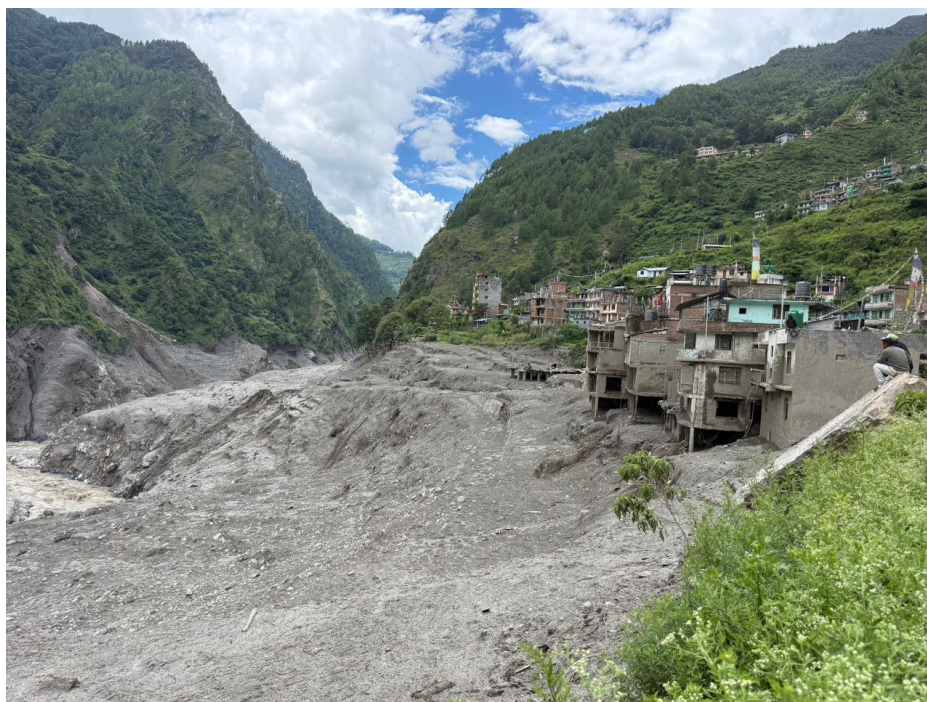
*Figure 1: Syabrubesi After the flash Flood (Photo Credit: Umesh Pathak, KU)*

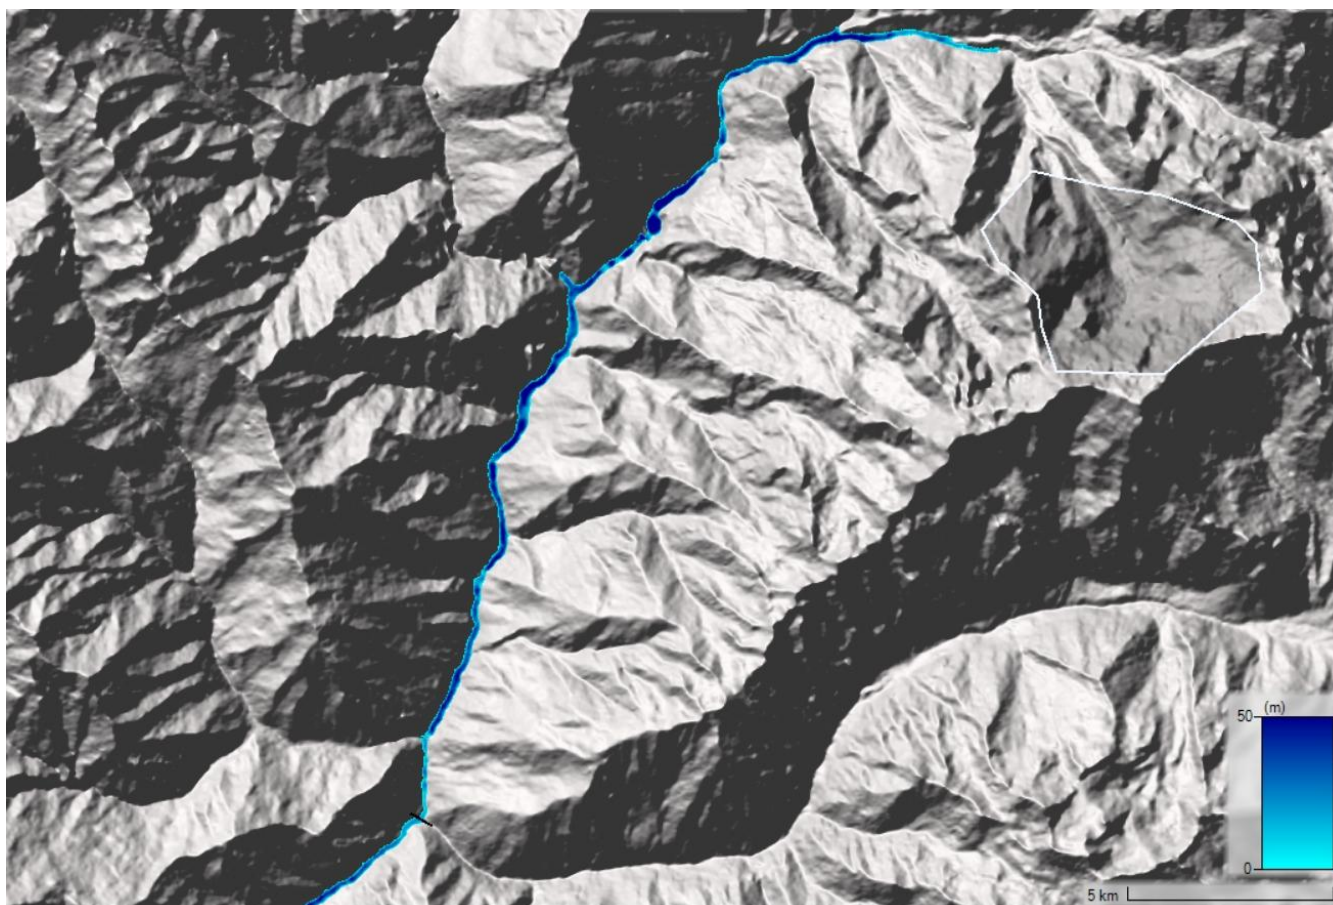
Figure 5. Water depth distribution map of the flood water.

The HEC-RAS analysis with 120.96 million  $\text{m}^3$  (Figure 3) of water shows that the maximum velocity was 15 m/s (Figure 4) from the Lhende River, where snow, ice, and water with debris struck the river to about 15 km downstream, maximum depth of 15 m (Figure 5), and maximum discharge of 23,000  $\text{m}^3/\text{s}$  at Syafrubesi (Figure 6).

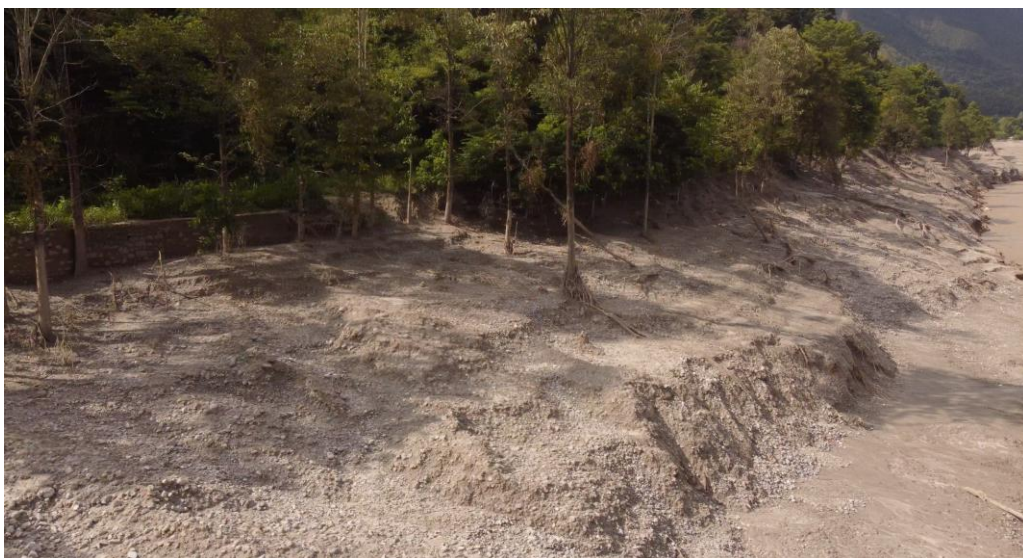
Figure 13: A section of river bank impacted by the floods

The catastrophe's impact on biodiversity is largely unknown, but a flood of this scale can seriously affect aquatic and terrestrial ecosystems and the services they provide. Riparian floodplains (shrubs, wetlands, water channels, sandbars, and grasslands) support aquatic and terrestrial species, including the globally endangered Golden Mahseer (*Tor putitora*) and the vulnerable Asala/Snow Trout (*Schizothorax richardsonii*); these may have been severely affected or locally eliminated. These ecosystems also act as natural buffers that reduce flood risk and provide fishing and other livelihood resources. Loss of vegetation and riverbank destabilization may increase the risk of further erosion and landslides.
